# **A Guide to Restoring Your '36 Pontiac**

**(What the Manuals Don't Tell You)**

**By:  
Bob Shafto  
Andy Lee  
1988  
Rev. 2017**

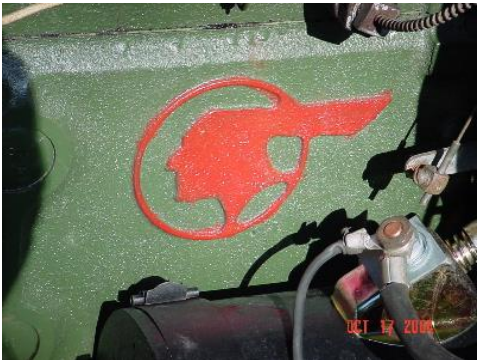
Early production "6" engine blocks had four frost plugs on the distributor side while later models had only two. Early versions also had narrower ridges in the top of the head than later versions. The date of manufacture of your engine can be determined from numbers stamped low on the block just in front of the starter (you may need a mirror to read them). The number will read something like GM • J 22 5. "J" tells you it was made in July (A is January); "22" is the day; and "5" means in the year 1935. The engine number is

found stamped into the upper left corner.

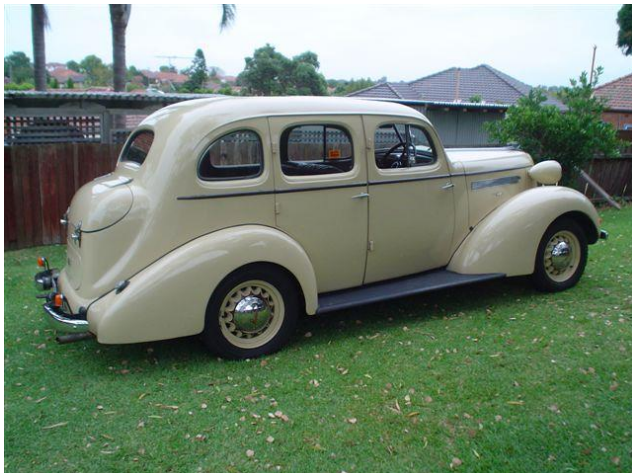
About 1,500 1936 Pontiacs were built in Australia by Holden. These cars had some significant differences from the US models. Here is a 4-dr touring sedan owned by Ron Taylor in New South Wales. Notice the front suicide door and different trunk. The bumpers are also different.
